# **Response of Fishes and Aquatic Habitats to Sand-bed Stream Restoration Using Large Woody Debris**

F. Douglas Shields, Jr.\*, Scott S. Knight, Nathalie Morin, and Joanne Blank

U.S. Dept. of Agriculture Agricultural Research Service National Sedimentation  
Laboratory, P.O. Box 1157, Oxford, Mississippi 38655-1157, USA.

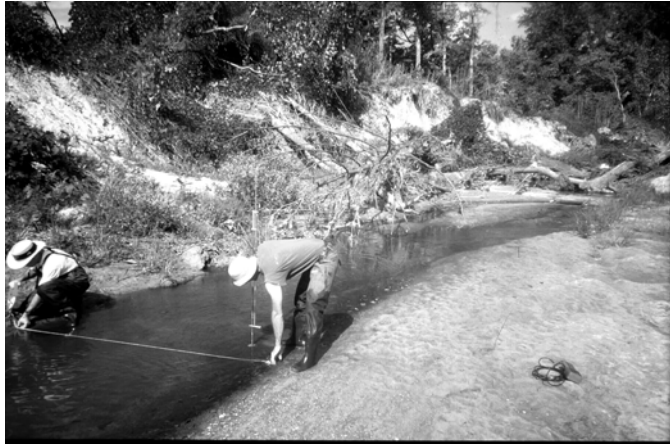
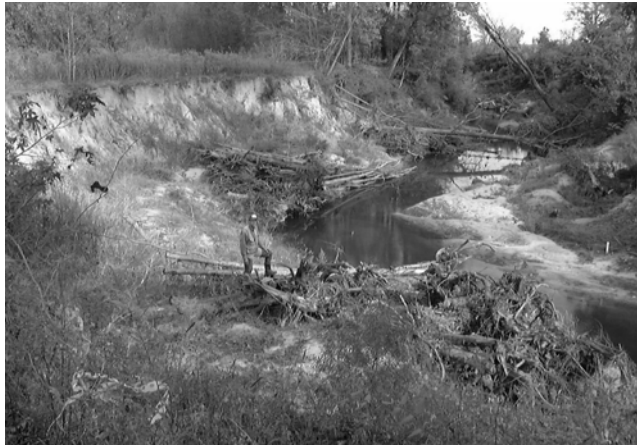
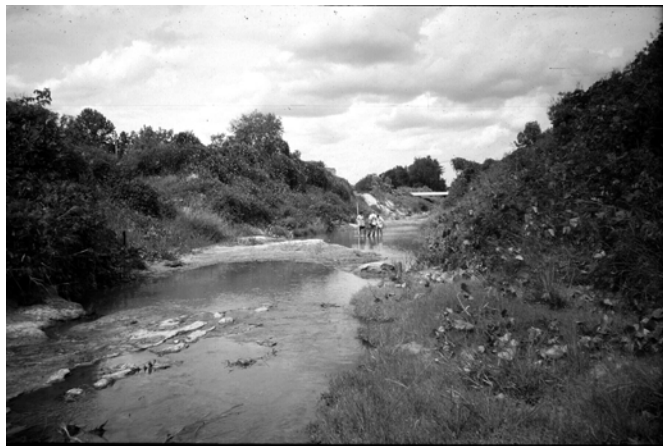
Figure 1. Reaches of Little Topashaw Creek, Mississippi sampled for this study.

a. Upstream.

b. Restored reach showing large woody debris structures on outside of bend one year after construction.

c. Downstream.

A site was selected along 2 km of Little Topashaw Creek, a fourth-order stream (1:24,000 topographic map) in north central Mississippi draining about 37 km<sup>2</sup> (Fig. 1). Criteria used in site selection included rapid bank erosion, an abundant supply of sandy bed material from upstream, nearby sources of native plant and animal colonists, and an advanced stage of incised channel evolution (Simon & Darby, 1999). The single-thread, meandering channel had an average sinuosity of 2.1, an average slope of 0.0025, an average width of 33 m, and an average depth of 3.6 m. Channel bed materials were primarily 0.2 to 0.3 mm sand. Channel morphology was extremely dynamic, typical of incising channels in the region. Historical air photos suggest mean channel width increased by a factor of 4 to 5 between 1955 and 1997. Surveys of 13 cross sections before and after a flow of 55 m<sup>3</sup> s<sup>-1</sup> (peak stages reached mid-

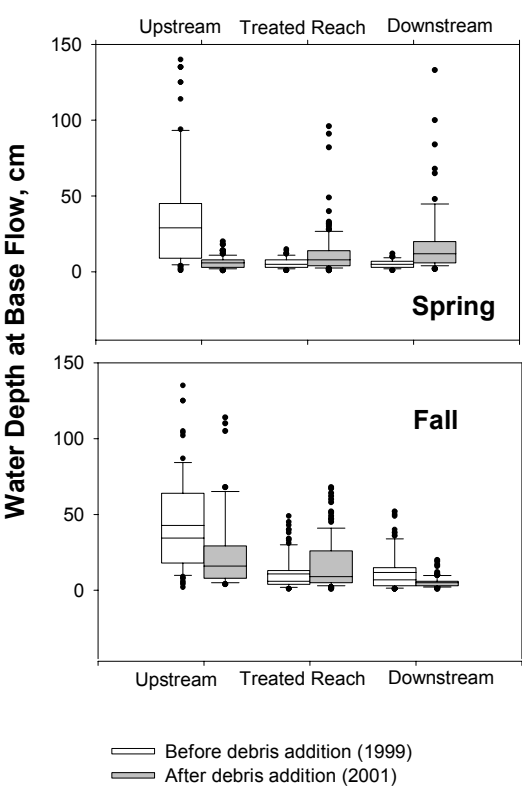
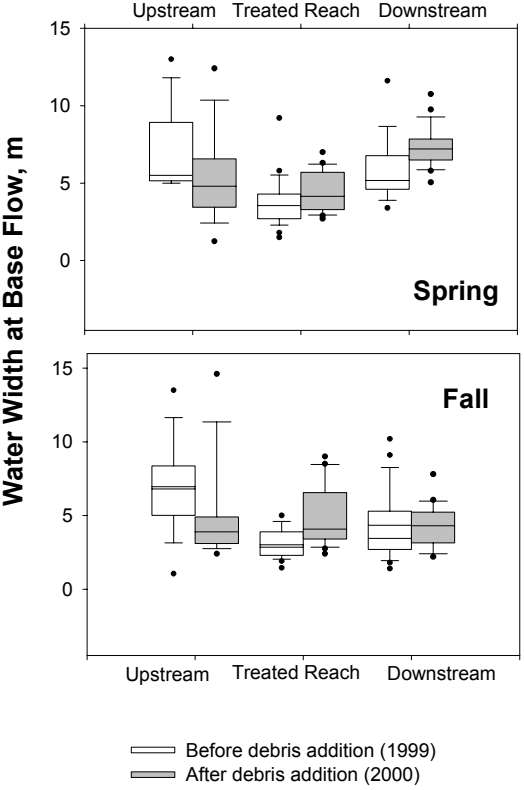
Figure 2. Distribution of water depth and width before and after addition of woody debris to restored reach in late summer 2000. The boundary of each box closest to zero indicates the 25th percentile, horizontal lines within the boxes mark the mean and median, and the boundary of each box farthest from zero indicates the 75th percentile. The error bars above and below the box indicate the 90th and 10th percentiles. Outliers are shown as point symbols.

Physical habitat data collected at similar discharges before (Spring =  $0.048 \text{ m}^3 \text{ s}^{-1}$ , Fall =  $0.018 \text{ m}^3 \text{ s}^{-1}$ ) and after (Spring =  $0.043 \text{ m}^3 \text{ s}^{-1}$ , Fall =  $0.012 \text{ m}^3 \text{ s}^{-1}$ ) construction showed that scour adjacent to the woody debris structures and beaver dams resulted in deeper ( $\sim 2\times$ ) and slightly wider aquatic habitats at baseflow relative to pre-construction conditions (Fig. 2). Untreated reaches up- and downstream became shallower or were unchanged. Water depths were greater in the upstream reach than within the treated reach or downstream due to the presence of several upstream-migrating nickpoints. The upstream reach was typical of a

transitional phase that is a precursor of the inferior conditions downstream (Shields et al., 1998). The treated reach became significantly deeper following debris addition ( $p < 0.003$ , Mann-Whitney Rank Sum Test) while Fall depths were shallower in comparison reaches ( $p < 0.002$ ). Trends in water surface width were not as clear (Fig. 2). However, mean water width in the treated reach increased from 3.0 m in Fall 1999 (before addition of woody debris structures) to 5.0 m in the Fall of 2001. The dye experiment showed that debris structures increased flow resistance, moderated velocities and increased retention time (Fig. 3). Mean velocity for the treated reach was  $17 \text{ cm s}^{-1}$ , but  $29 \text{ cm s}^{-1}$  for the downstream reach. Although the mean velocity was less in the reach treated with debris, dispersion was nearly the same for both reaches, as evidenced by the width of the dye curves in Fig. 3. Acoustic-Doppler loggers recorded velocity magnitudes within debris structures that were only 50% to 60% of those measured in the channel adjacent to the structure or in the bend without debris structures (Fig. 4). Velocities within the debris structure were generally less than  $30 \text{ cm s}^{-1}$ , and usually below  $10 \text{ cm s}^{-1}$ , even during events that were large enough to produce flow depths  $> 3 \text{ m}$ . Events with depths of only  $\sim 1 \text{ m}$  produced velocities  $> 100 \text{ cm s}^{-1}$  in the bend without debris structures. Habitat preferences of centrarchids and ictalurids generally lie within the  $10$  to  $50 \text{ cm s}^{-1}$  range (e.g., Stuber et al., 1982, McMahon and Terrell 1982).

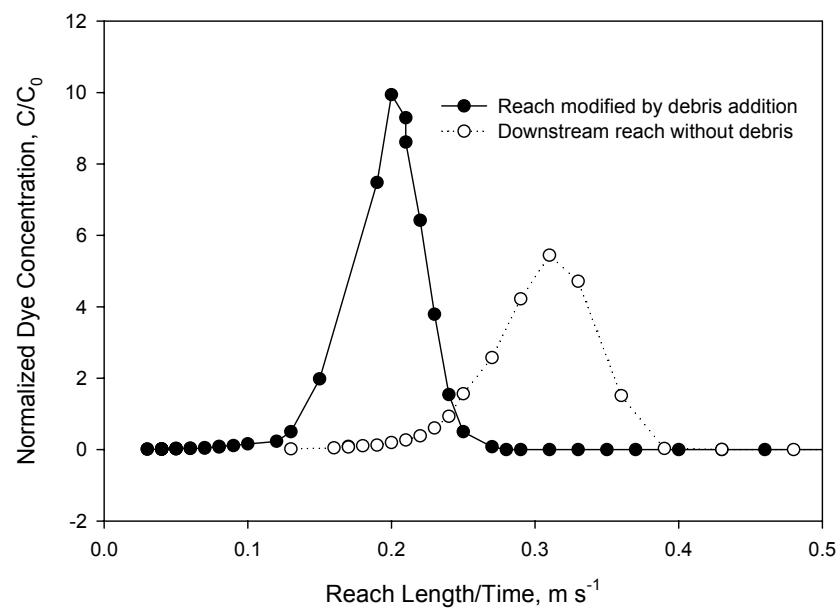
Figure 3. Tracer dye concentration curves following slug injection of fluorescent dye. X-axis represents reach length divided by time.

Effects of debris addition on flow patterns that contribute to retention of fine particulate organic matter were quantified using a tracer dye experiment 9 months after construction. Discharges during the dye experiment ( $\sim 0.3 \text{ m}^3 \text{ s}^{-1}$ ) were above base flow, but well below high flow levels. Slug-injections of Rhodamine WT dye were made upstream and

downstream from the treated reach, and passage of the resulting dye cloud was documented by periodically collecting grab samples for several hours 1.3 to 1.7 km downstream from the injection points. The reach traversed by the downstream dye cloud had similar flow resistance characteristics (bed slope, channel cross section, bed material size, sinuosity) to the treated reach except for the presence of the debris structures and the attendant features created in the channel bed by scour and deposition adjacent to the structures. The downstream study was completed first to avoid interference from the upstream injection. Time-concentration curves were normalized by dividing the time values by reach length.

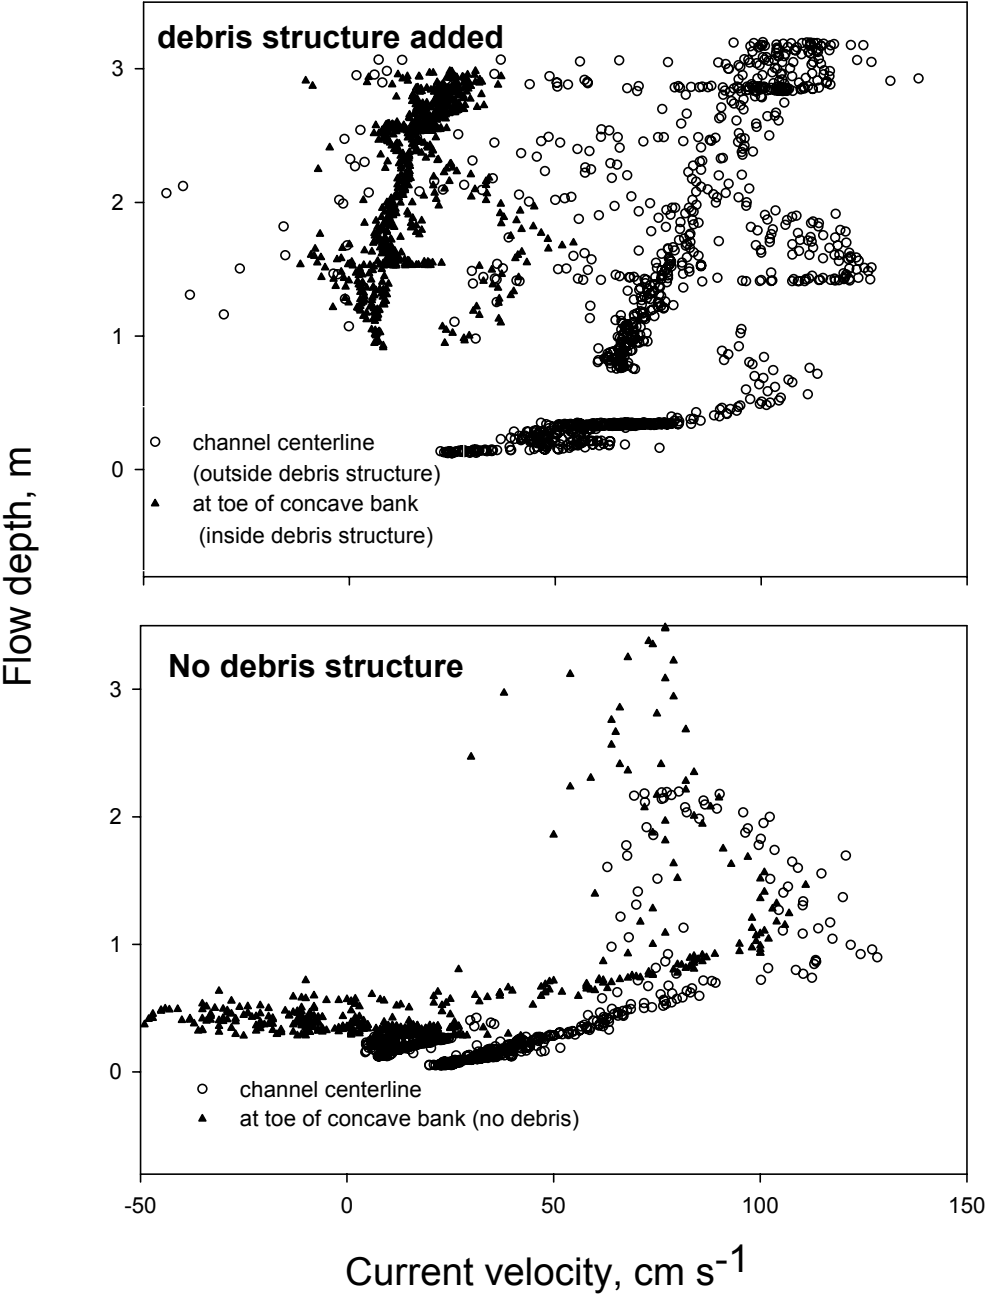
Figure 4. Effect of large woody debris structures on high flow velocities. Velocity measured by acoustic-doppler loggers is plotted on the x-axis against simultaneous records of flow depth plotted on the y-axis for locations within bends with (top) and without (bottom) debris structures along the outside of the bend.

Effects of debris on aquatic habitats during high flows were observed using acoustic-Doppler depth-velocity loggers as described by Shields et al. (2001). Loggers were secured above the stream bed along a transect across the channel within a bend where debris structures had been placed on the concave bank and within an unmodified, eroding bend with similar geometry to the modified bend. Depth and velocity measurements were recorded every 5 min during major runoff events. Debris effects on erosion and deposition were quantified using cross-section and thalweg surveys conducted before and during the first year after construction.

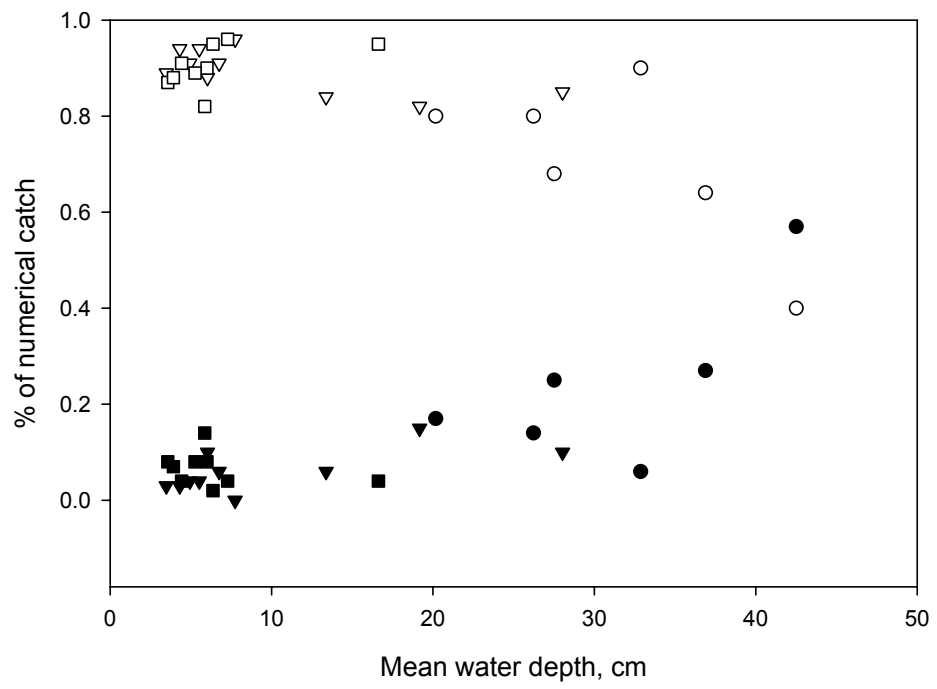
Figure 5. Response of cyprinids (white symbols) and centrarchids (black symbols) to changes in mean water depth. The percent of catch by number for upstream, restored, and downstream reaches are represented by circles, triangles, and squares, respectively. Thus white circles show the percent of numerical catch from the untreated upstream reach

comprised by cyprinids, while black circles represent the centrarchids within the same samples.

Changes in fish population density, average size, and community structure (Table 1) mirrored trends observed in other incised stream ecosystems (Shields et al., 1997 and 1998). Collections were dominated by cyprinids (90% of numbers, 64% of biomass) and centrarchids (6% of numbers, 27% of biomass), but the relative dominance of cyprinids was inversely related to the mean water depth ( $r^2 = 0.30$ ,  $p = 0.002$ ) (Fig. 5). Opposite trends were indicated for numbers and biomass of the centrarchids with  $r^2 = 0.59$  and  $0.54$ , for the association between percent of numerical and biomass catch, respectively, and mean depth ( $p$

< 0.00005). Addition of pool habitat following debris addition increased the fraction of numbers and biomass comprised by centrarchids in the treated reach from 3% to 10% and from 13% to 23%, respectively. Species richness was unaffected by debris addition, but the average number of species per 150-m reach increased in all three zones (upstream, within the treated reach, and downstream) following debris addition (Table 1). Relatively large changes in fish numbers, biomass, and species richness observed in the downstream reach (Table 1) may have been due to export of benthic drift and organic matter from the treated reach. Three species typically associated with deeper habitats were captured in the treated reach following debris addition but not before (*Micropterus salmoides*, *Lepomis megalotis*, *Ictalurus punctatus*), and *M. salmoides* was found only in the restored reach. Although changes in the size of centrarchids were not statistically significant ( $p > 0.16$ , Mann-Whitney Rank Sum Test) in any of the zones, only one of the 27 centrarchids captured in the two years before debris addition was longer than 10 cm, but 4 of the 40 captured afterward were longer than 10 cm.
